MEMORIAL HEALTHCARE

- **CUSTOMER** Memorial Healthcare
- LOCATION Owosso, Michigan, USA
- **BACKGROUND** Memorial Healthcare in Owosso, Michigan is committed to providing patients with a healthcare experience of the highest possible quality. For the facilities manager, this mission extends to identifying and mitigating risks that would compromise the safety of patients and staff.
 - PROBLEMSAware that waterborne pathogens could develop within the scale buildup of
their domestic hot water system, Memorial Healthcare's facilities manager was
concerned about the risks, especially for immunocompromised patients. The
maintenance team had explored several chemical options for scale removal,
however none of these were implemented because the potential benefits did not
outweigh the new risks they presented.

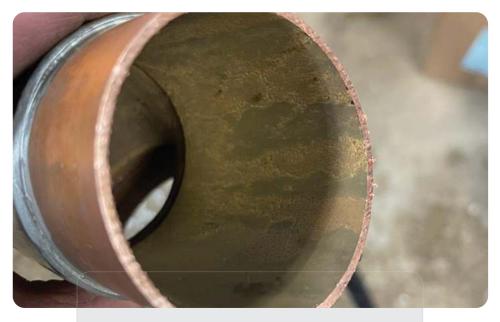
Nanobubbles starting to remove scale on a sample of pipe from Memorial Healthcare's domestic hot water system.

SIGNIFICANT Within months, the facilities team noticed results. The reduction in scale on copper **RESULTS** pipes was visually confirmed when a portion of the domestic hot water pipeline was replaced in one of the buildings.
